Smoleńsk Maze

**CRASH OF THE POLISH AIR FORCE ONE
SMOLEŃSK, RUSSIA, APRIL 10, 2010**

2014 STATUS REPORT

MARIA SZONERT BINIENDA

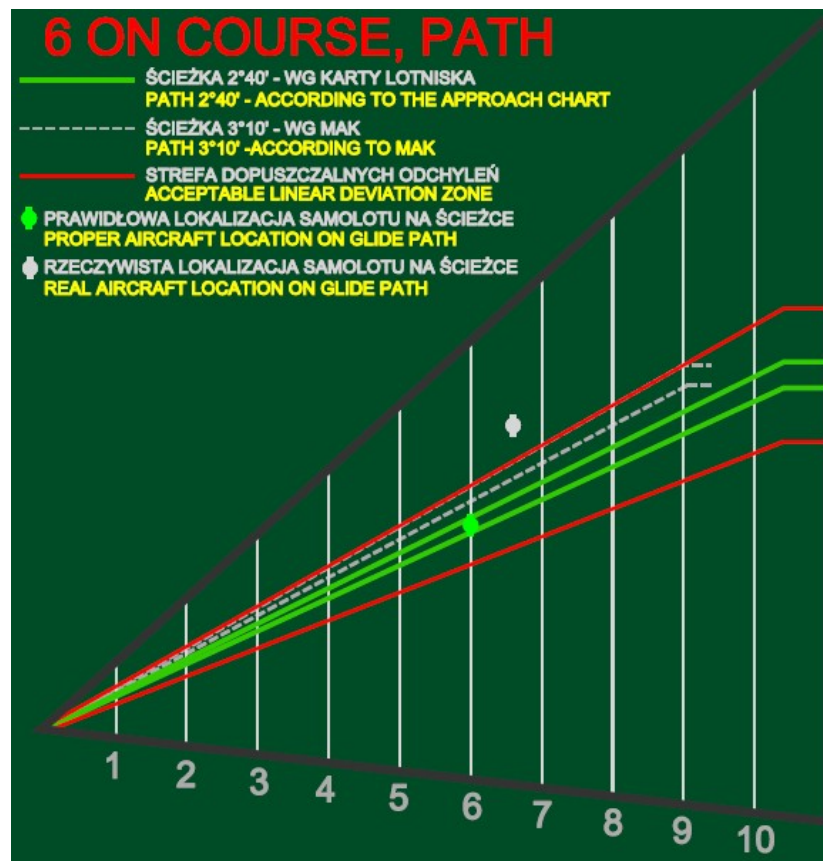
Contrary to the transcript above, the Polish Air Force One in his final approach to the Severny Airport in Smolensk was not on course and was not on a glide path at the times specified in the above transcript.

[3] The actual position of the Polish Air Force One versus the correct approach path at 6 km before the airdrome. Source: K. Matyszczyk

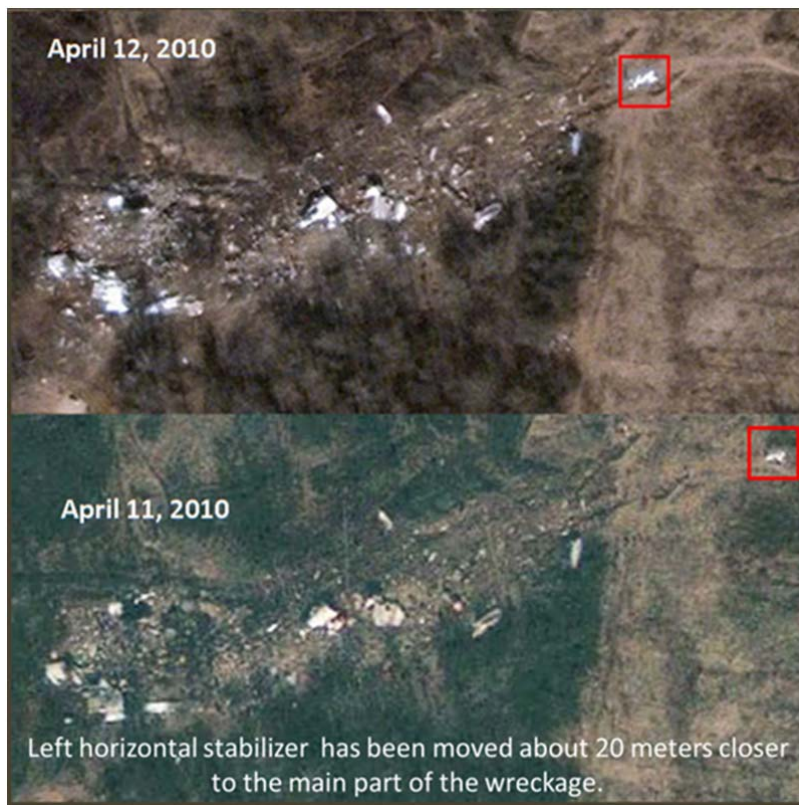
Satellite pictures of the crash site taken by the GeoEye satellite demonstrate that the ground position of the plane's left horizontal stabilizer was moved between April 11 and April 12 over 20 meters closer to the first marks on the ground of the wreckage site. The new position from April 12 was considered as the original position in the Russian Report.

[4] Position of left horizontal stabilizer on April 11 vs April 12.
Source: K. Nowaczyk.

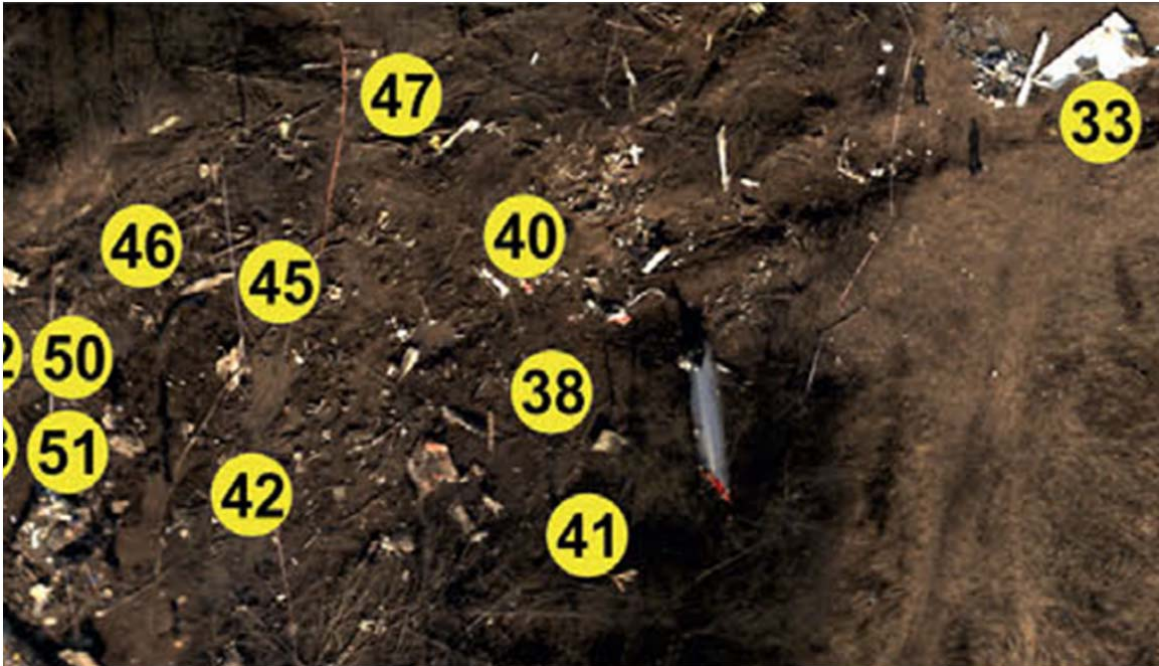
[5] Left stabilizer marked as item 33 in a new position. Source: Figure 35, Russian Report.

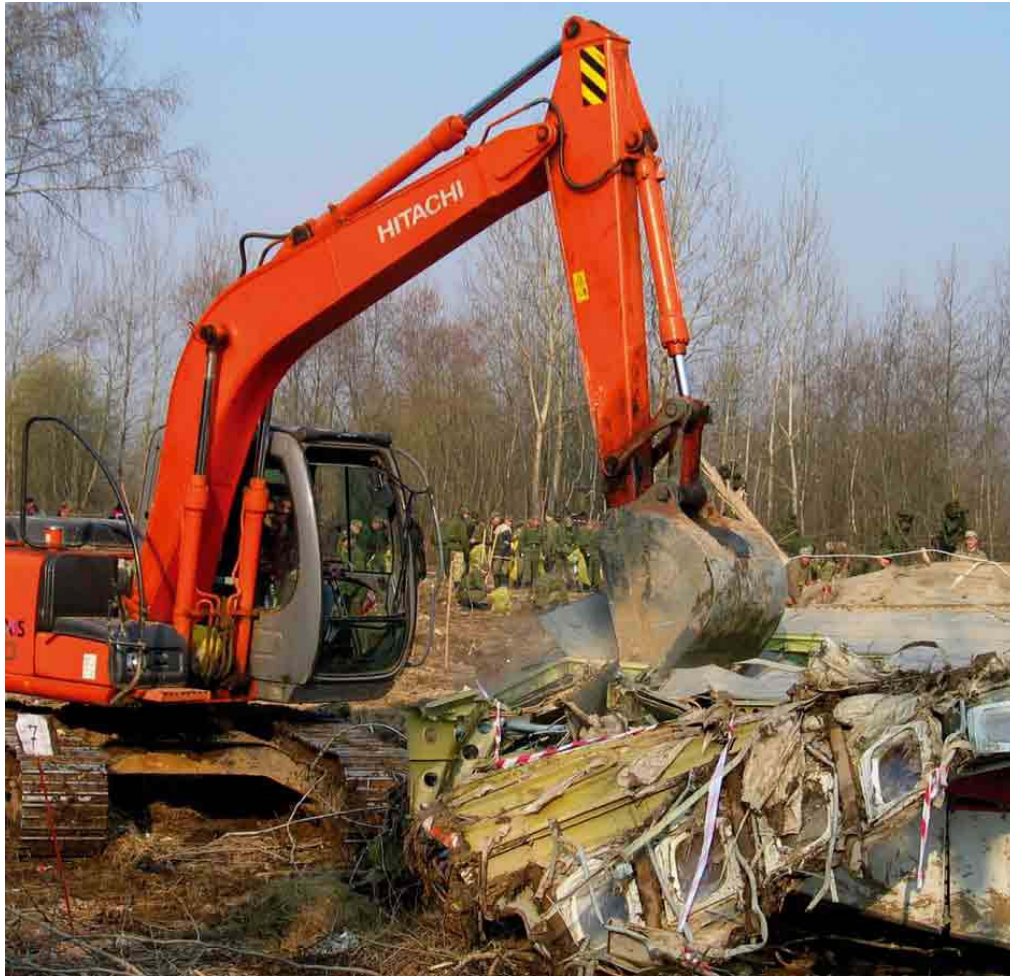
The destruction of the airplane debris took place the next day after the crash without assuring adequate documentation regarding the position of the debris, without photographing the original shape of the debris, and properly marking the fragments for future reconstruction. Instead, all windows in the fuselage were smashed immediately after the crash, large sections of the airplane were cut and crashed by heavy equipment, cables were cut and pulled out, heavy parts were further deformed and damaged by being dragged by excavator and heavy machinery, large areas of the crash site with smaller debris were bulldozed, some parts of the crash scene were quickly covered up with fresh soil or with concrete. Deformation of the tail of the airplane was 'repaired' before it was moved to the final storage site. Finally, largest airplane parts were moved to the concrete pavement of the airport and were left there without any protection for many months. Several tons of small parts were piled up nearby like trash without any order or protection.

[6] Handling of the Wreckage of the Polish Air Force One on April 11, 2010.
Source: J. Gruszczyński

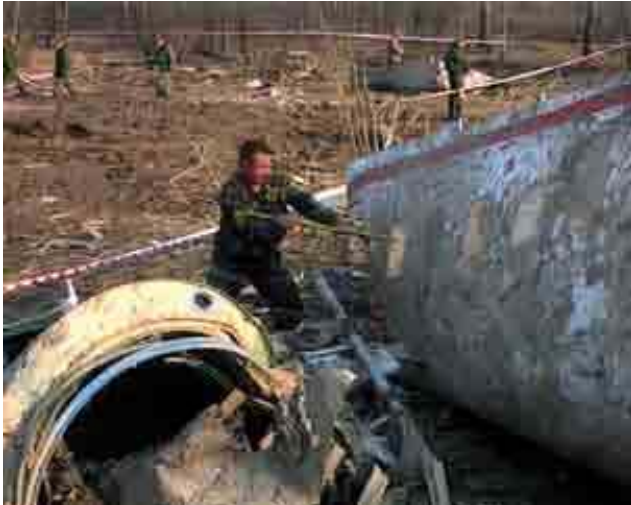
[7] Destruction of windows in the fuselage on April 11, 2010
Source: A. Gargas

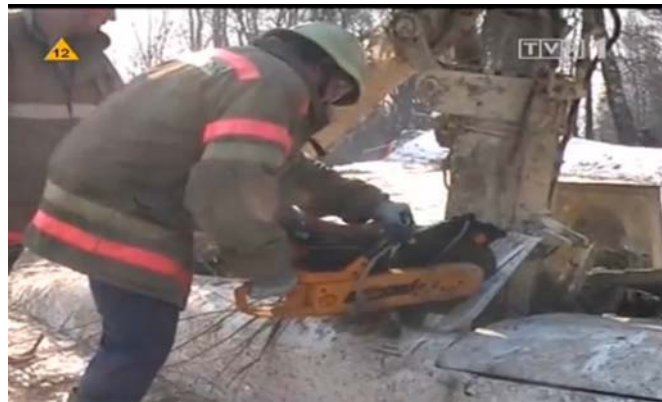
[8] Cutting of the wing, April 11, 2010
Source: A. Gargas

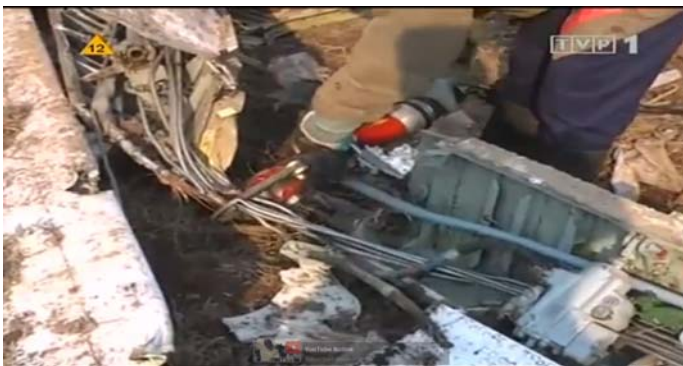
[9] Cutting electric wires, April 11, 2010; Source: A. Gargas

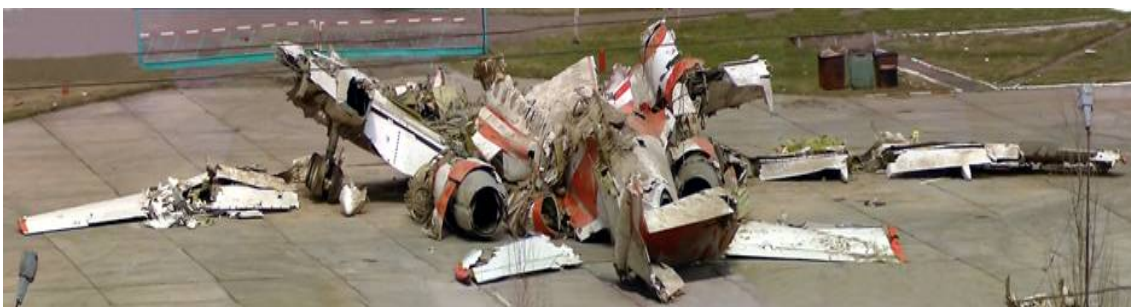
[10] Wreckage of the Polish Air Force One on the pavement of Severny Airport.

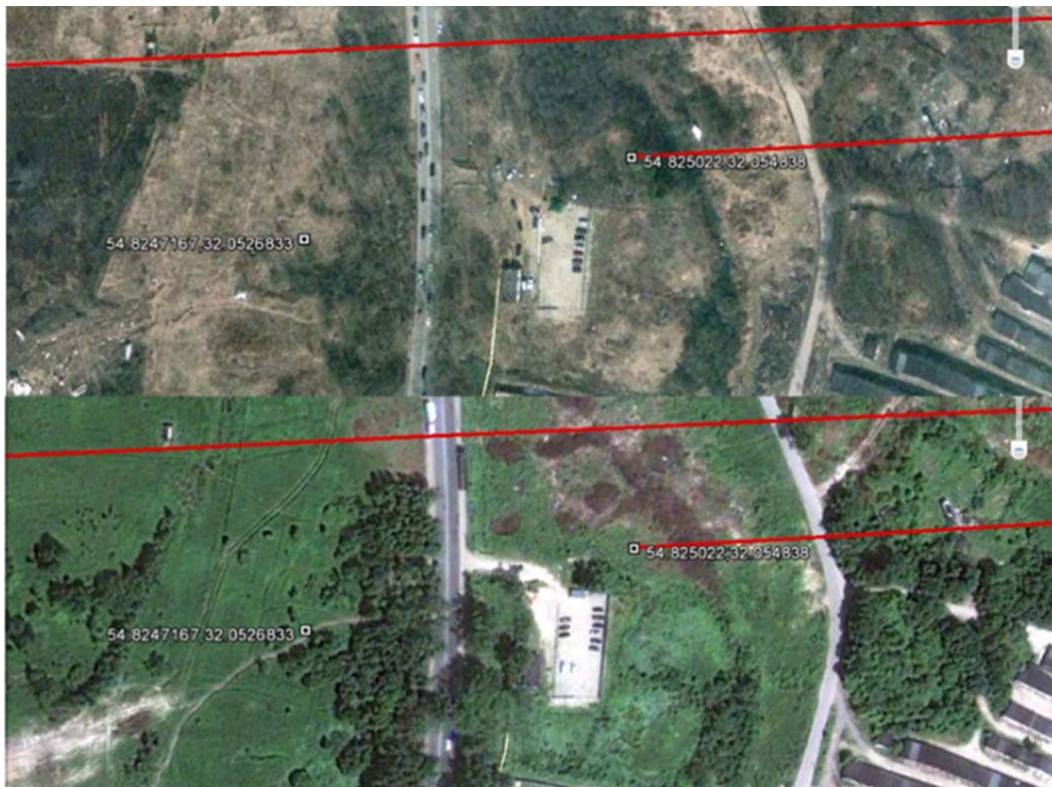
Many trees and shrubs were cut down in the vicinity of the crash site, grass was burnt and top soil was removed, especially near the location of Terrain Awareness and Warning System (TAWS) number 38, which was hidden in the Russian Report.

[11] TAWS #38 area: satellite photo from April 12, 2010 (top) and June 24, 2010 (bottom); the lack of normal growth can be observed on the June photo in the area of TAWS # 38. Source: K. Nowaczyk

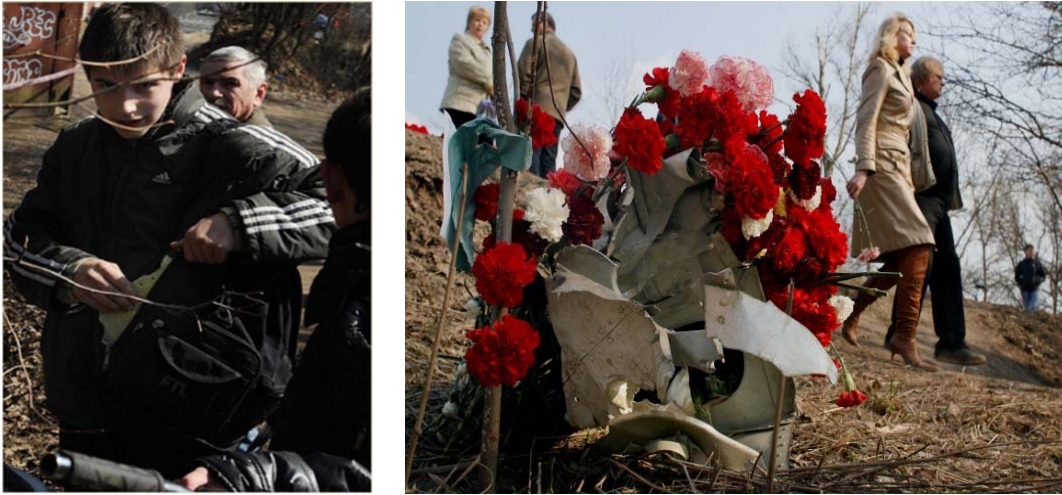
[12] Crash Site Unprotected; Source: K. Nowaczyk

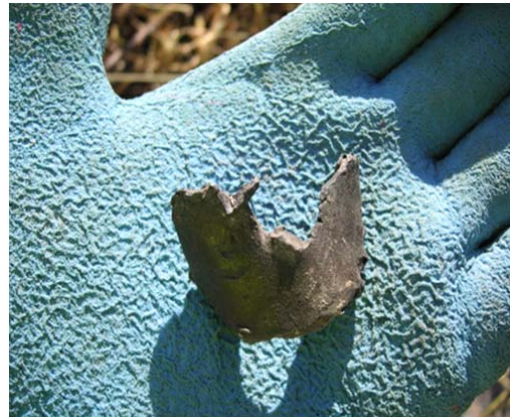
Six months after the crash, a team of Polish archeologists was finally allowed to examine the crash site. The Polish experts found ten thousand small pieces of debris on the surface, including 28 pieces of human remains, and identified with metal detectors sensing up to 20 cm deep another twenty thousand fragments of metal pieces hidden in the soil up to 20 cm deep. Using several drills, they confirmed that near the location of every small metal fragment there were on average another six non-metal fragments. Some metal fragments were exposed to high temperature. The large number of small debris and characteristics of the debris are typical to explosion.⁵⁶

[13] Example of a piece of debris found before the main crash site by Polish archeologists 6 months after the crash.

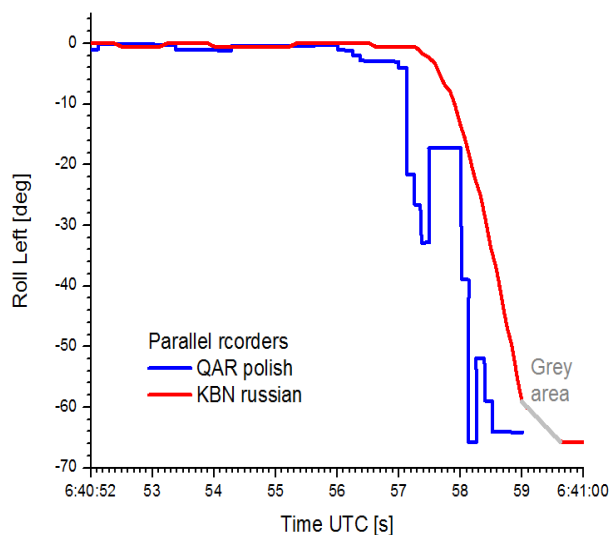
Data recovered from some of the aircraft's recording devices have been subject to arbitrary alterations and some of the data from FMS and TAWS logs have not been included in the Russian analysis at all. Figure 15 shows an example of significant differences between recorded values by Russian KBN recorder (red) and Polish QAR recorder (blue). Both recorders are collecting data from the same sensors.

The grey area at the bottom of the graph in Figure 15 indicates a place where the Russian analytic program WinArc32 used by IAC removed “uncertainly” data points. [15]. Recorded left roll from parallel recorders. Source: K. Nowaczyk

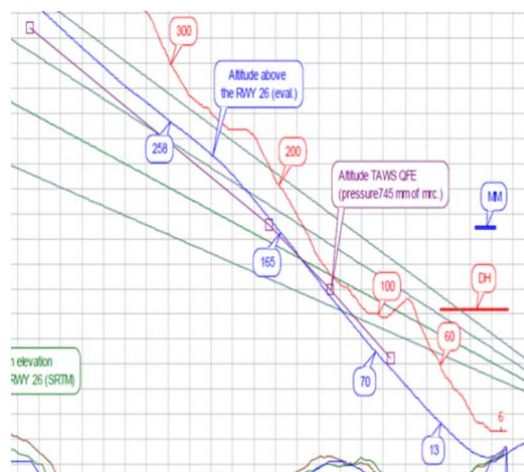
The Russian Report omits TAWS #38 event landing completely. See Figure 16.⁶⁸ The blue line (TAWS baro-altitude) does not contain any explicit information from TAWS #38 or any of the FMS logs. The last mark on the blue line indicates TAWS #37.

[16] No TAWS 38 in the Russian Report

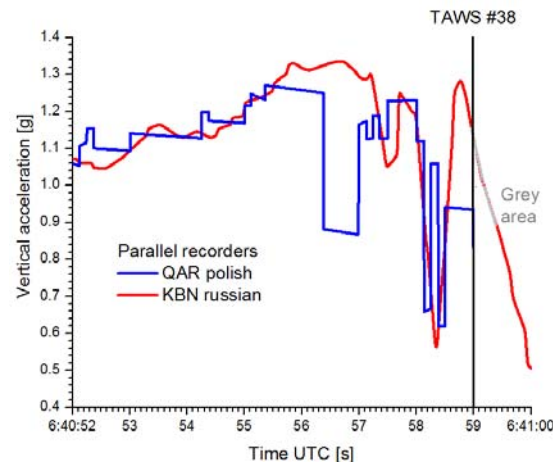
Figure 17 shows a vertical acceleration chart from the Russian Report (red line),⁶⁹ and the same data from the Polish QAR recorder (blue line). Both graphs show two peaks occurring in very fast succession, on the order of one tenth of a second. They both occur before TAWS #38, around 200 m before crash site. These strong changes of acceleration must have been caused by a powerful downward-acting force but are not explained in the Russian Report.

[17] Vertical acceleration from Russian and Polish black boxes. Source: K. Nowaczyk

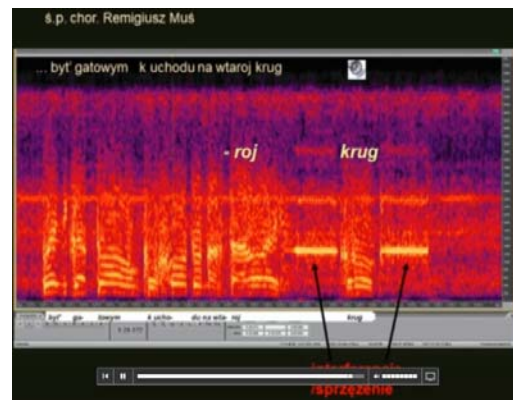
Numerous problems have been raised in connection with the acoustic reading of the flight data recorders. The problems range from different lengths of the same recording, the lack of professional analysis of acoustic image of the recording, incorrect read-out and interpretation of the recordings to fundamental problem with the reliability and integrity of the flight data

[18] Acoustic Analysis of FDR;
Source: A. Gruszczyńska-Ziółkowska

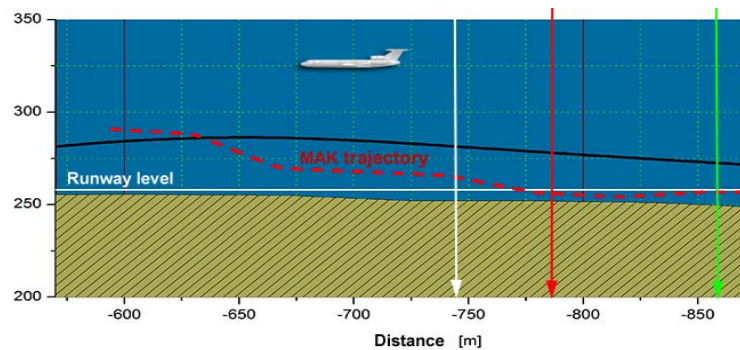
Vertical and horizontal trajectory presented by the Russians is wrong; (K. Nowaczyk, G. Jorgensen,) 76

[19] Russian trajectory vs. TAWS trajectory; Source: K. Nowaczyk

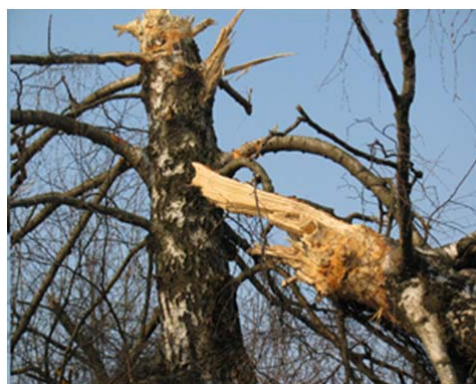
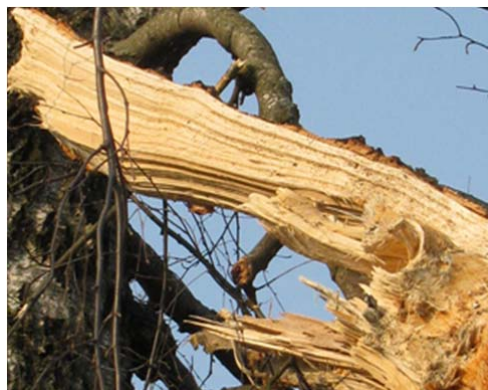
According to computer simulations, the birch tree could not cut off the left wing; (Prof. W. Binienda). The birch tree was already broken before the crash. (Prof. C. Cieszewski).⁷⁷

[21] The birch tree that allegedly cut off the wing. Source: J. Gruszczyński, C. Cieszewski

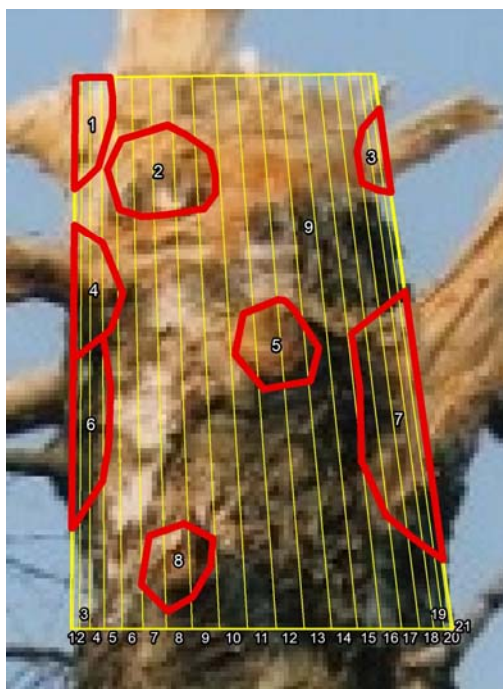
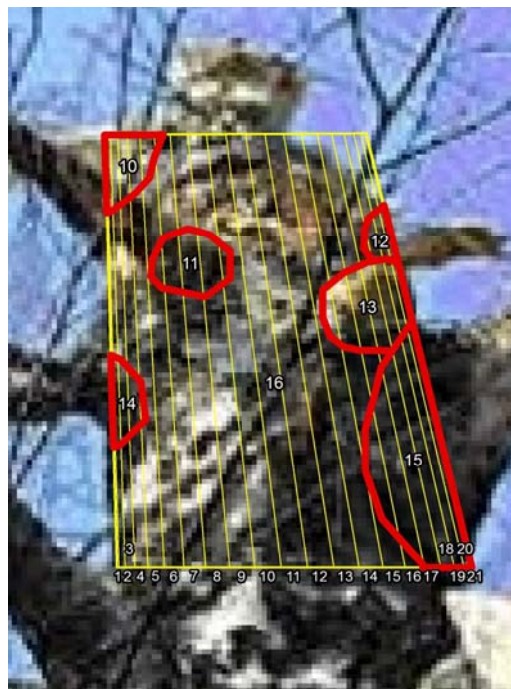
[22] Strength of the birch tree reduced due to numerous knots. Source: C. Cieszewski.

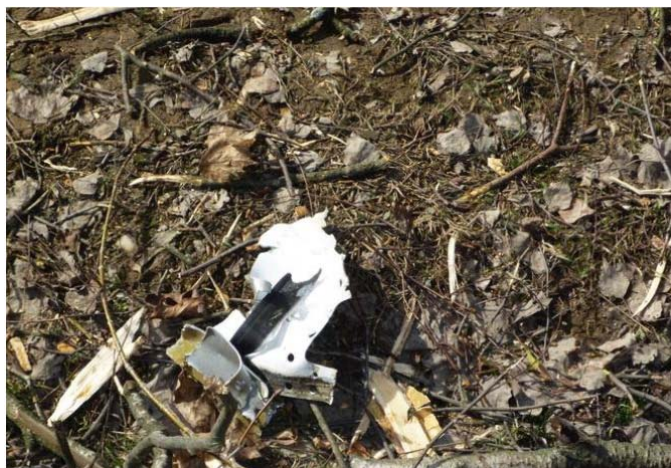
The wreckage of the plane, shape of debris and conditions of the bodies point to explosion in mid air. (G. Szuladzinski, J. Obrębski, S. Zagrodzki).

[23] A piece of debris characteristic of explosion: Source: Analytical Services Pty Ltd

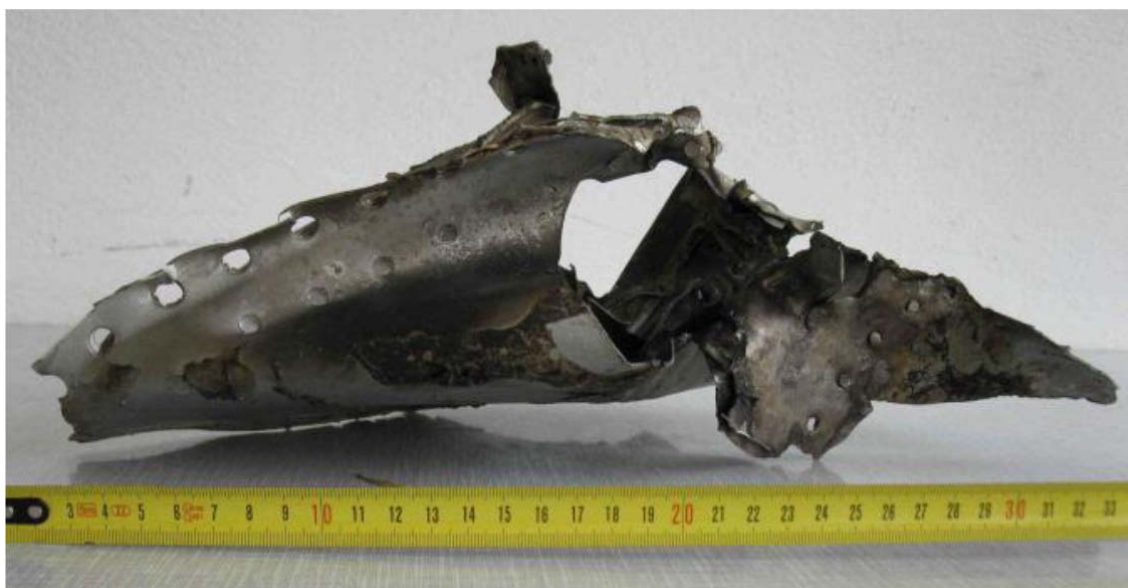
[24] A piece of debris showing signs of explosion; Source: Prof. J Obrębski.

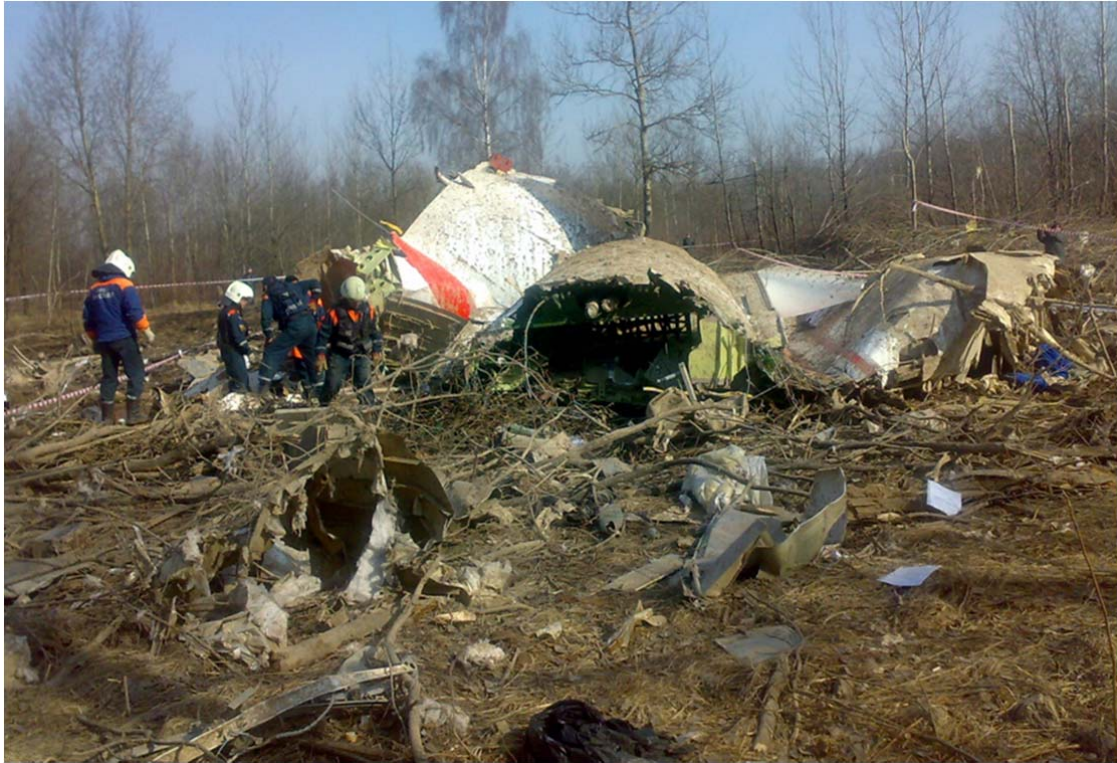
inverted in the air, and hit the ground in the inverted position. Thus, the wreckage fell to the ground inverted with both side walls of the fuselage bent outside. One wall of the fuselage was turned outside to the left and the other wall was turned outside to the right. According to Prof. W. Binienda, this configuration of the fuselage at the crash site is only possible as a result of explosion in mid-air.⁷⁹

[25] A part of the fuselage inverted and opened up. Source: Polish Parliamentary Committee

The fuselage burst into many pieces. The front parts of the fuselage and the cockpit were not inverted while rear parts of the fuselage were found in the inverted position. All cargo was blown away from the cargo space. Gears were in revers position. All passenger seats disintegrated into pieces and the bodies of the victims were either found in small pieces, or without external clothing, or not found at all. Pieces of burnt human remains were found far away from the fire zone. The evidence points out to several explosions in mid-air at a low altitude as the only explanation of the type of damage documented at the crash site.
