Smoleńsk Maze

**CRASH OF THE POLISH AIR FORCE ONE
SMOLEŃSK, RUSSIA, APRIL 10, 2010**

2014 STATUS REPORT

MARIA SZONERT BINIENDA

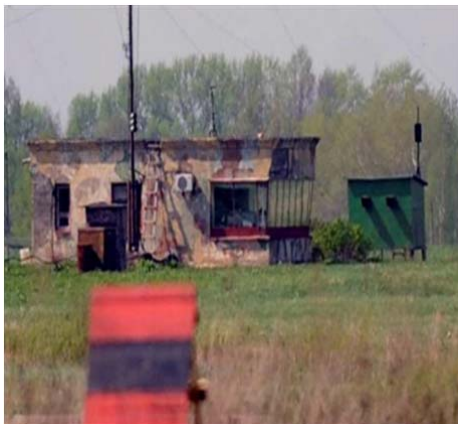
Despite a series of fundamental problems with the performance of the FCG at the Severny Airport on April 10, 2010, including obvious violations of Russian Federal Regulations, the Russians found no errors, irregularities or violations of law in the operations of the FCG.²¹ Various analyses presented in the Russian Report address a number of ancillary issues but disregard the most important analysis of the FCG performance.

[2] Air Traffic Control Tower
Severny Airport in Smolensk
April 10, 2010

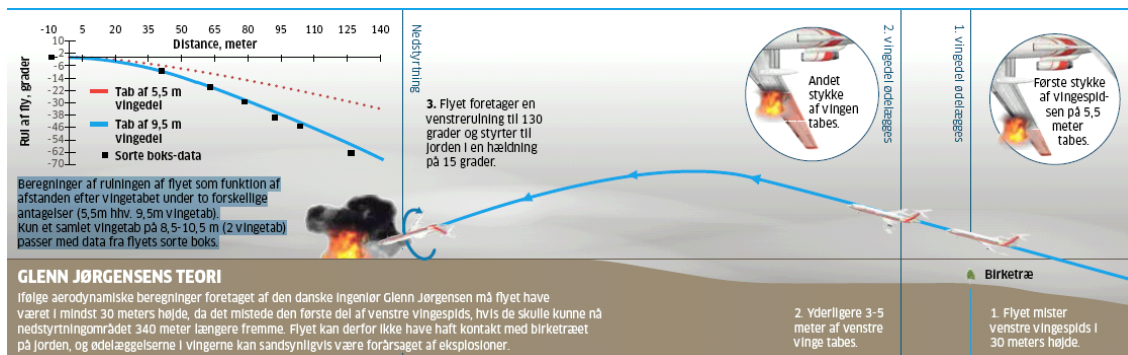
[20] Danish Engineer G. Jorgensen Rejects Russian Trajectory; Source: Ingeniøren, 02. 21. 2014.
